Initiation of an Urgent: Medical Device Correction (see attachment) - Dexcom Non-Touchscreen Receiver:

Urgent: Medical Device Correction UPDATE
Dexcom G6 Receiver – MT27408-1, Dexcom G7 Receiver – MT26403-0

Description of the Problem:

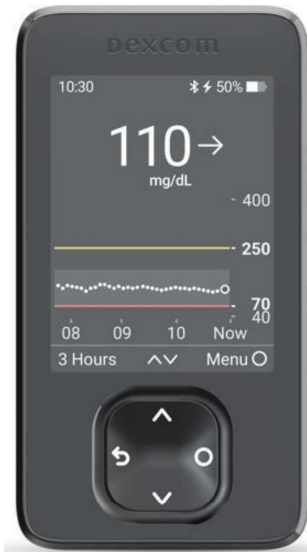
Front of Receiver
Example Rendering:

Image 4: Examples of Affected Receiver

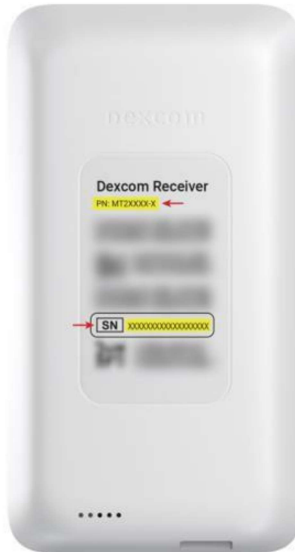
Back of Receiver
Example Rendering:

- Note: The part number and serial number are both listed on the back of the receiver as shown in the image to the right/below):

- Verify if your receiver is affected by this issue: Check the serial number for any receiver(s) you use, with a part number listed in Table 1, by visiting this webpage:
<https://dexcom.com/en-us/checkreceiver>
